# DETECTION, LOCATION, AND CLASSIFICATION OF SPACE SHUTTLE MAIN ENGINE NOZZLE LEAKS BY TRANSIENT THERMOGRAPHIC INSPECTION

Samuel S. Russell  
Nondestructive Evaluation Team  
NASA Marshall Space Flight Center  
256-544-4411  
sam.russell@msfc.nasa.gov

James L. Walker  
Center for Automation and Robotics  
University of Alabama in Huntsville  
256-890-6578 ext. 207  
walkerj@email.uah.edu

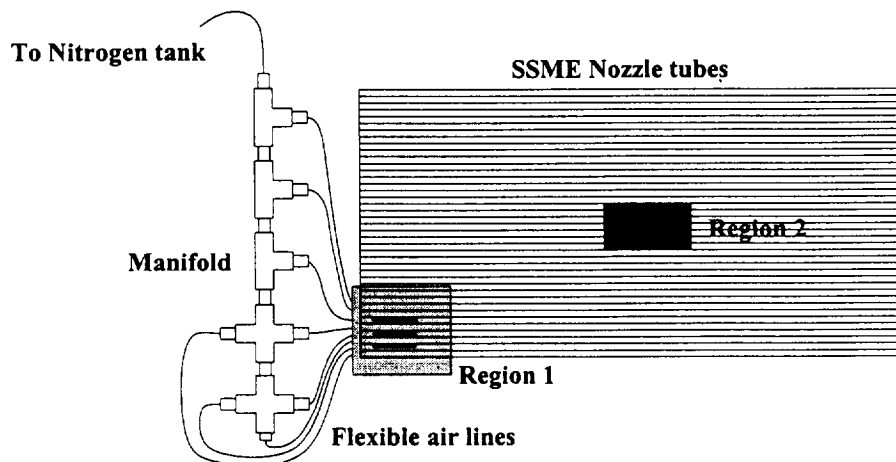
Figure 4. Configuration for panel from lower nozzle region with manufactured leaks.

Artificial defects were fabricated into a nozzle segment cut from the lower region of a scrap SSME nozzle including the eighth and ninth hat bands. By cutting open the tubing on the hot wall side of the nozzle, then puncturing the tube into the interstitial region and finally resealing the tube with a cover patch through a welding operation, phantom defects were fabricated, see Figure 4. The leak type and interstitial location were determined by individually pressurizing each tube and checking with leak solution.

In all cases no surface leaks were detected with leak check solution. For brevity only results for Region 1 are presented.

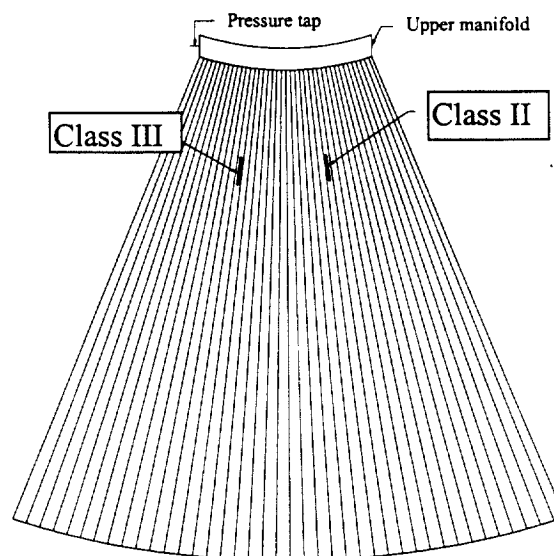
Figure 7. Location of defects in panel cut from the upper portion of a nozzle.

A second panel cut from the upper end of a nozzle was prepared with artificial weld defects that were classified as Class II and Class III as shown in Figure 7. The cooling tubes grow continuously from the top to the bottom of the nozzle creating a somewhat different problem at the top because of the much smaller tubes and interstitials. The Thermograms generated by rapidly (< 2 seconds) pressurizing the segment with 40 psig Nitrogen are shown in Figure 8. The difference between a Class II leak on the right and a Class III on the left is very apparent.
